Structural Health Monitoring Systems for Inflatable Softgoods Space Structures

FRANKLIN LI, CODY GRAY, LUJUN WANG,
ONTARIO NICHOLSON, RICO CHEN, YU CHEN,
JIM LI and AMRITA KUMAR

Franklin Li, Cody Gray, Lujun Wang, Ontario Nicholson, Rico Chen, Yu Chen, Jim Li, Amrita Kumar (Acellent Technologies, Inc.)

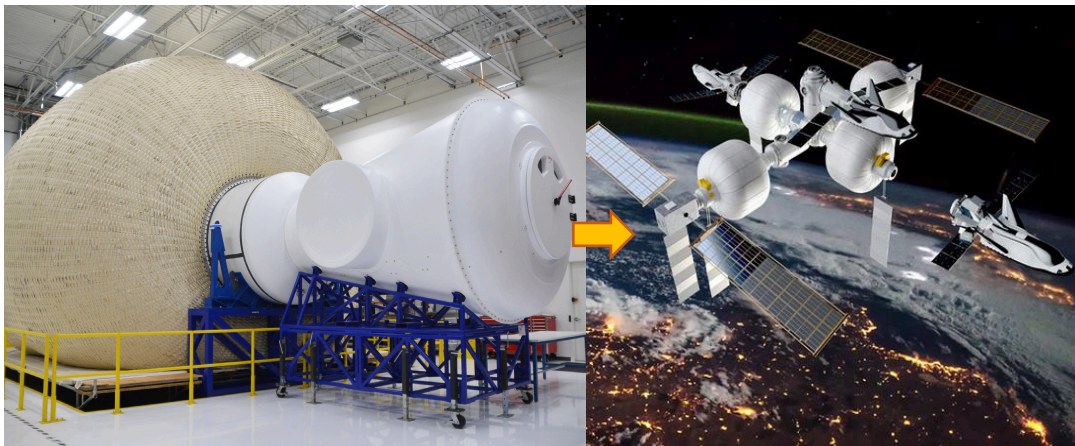
Figure 1. Example of inflatable space habitats (courtesy of ILC Dover).

Inflatable structures are being pursued as candidates for long-term habitats in space (Figure 1). The ability to monitor and assess the structural health of an inflatable module is an important factor in determining the feasibility of using such technologies for human habitat, especially in the presence of micrometeoroid and orbital debris (MMOD) threats. Flexible, hybrid Structural Health Monitoring (SHM) systems—which focus on the design, manufacturing, and integration of electronics and sensors—are essential for addressing some of the major impediments and challenges facing integration of multifunctional sensors and monitoring technologies into space habitat structures.

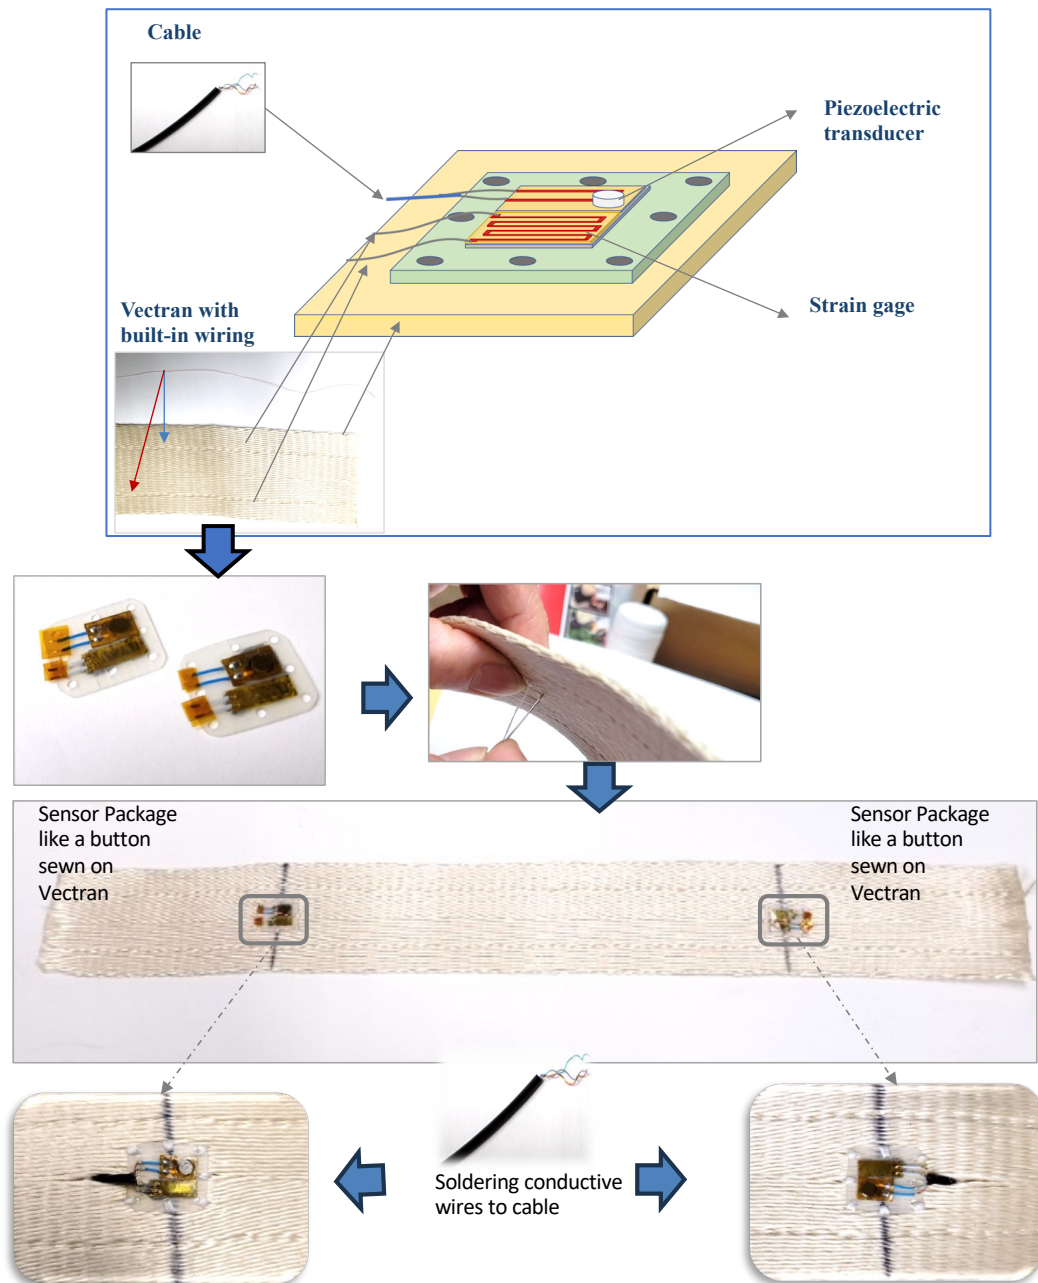
Figure 2. Preliminary design and integration of the sensor package with the Vectran webbing.

A conceptual design for a hybrid PZT and strain-gauge sensor package based on these criteria was developed as shown in Figure 2. The design assumes that built-in wiring can be used to connect to these sensors to the data-acquisition electronics for power and measurement. Once manufactured, the sensor packages can be sewn onto the Vectran fabric in any location, like a button.

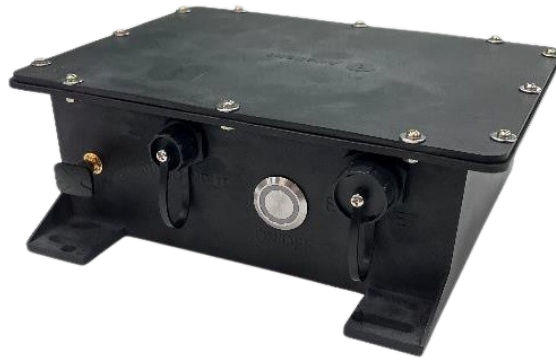
Figure 3. Accellent IMGenie Pro

Accellent's IMGenie Pro data-acquisition hardware was used throughout this project to provide impact detection and load/strain monitoring. It supports fully-simultaneous sampling from up to 32 PZT sensors at rates of 1,000 to 30,000 samples per second (sps), a resolution of 16 bits, an input range of ± 45 V, and integrated filtering. In addition to PZTs, the IMGenie Pro also supports acquiring data from up to 3 two-wire RTD sensors and up to 9 strain gauges, offering sampling rates of 2 to 4000 sps, 24 bits of resolution, gains of 1 to 128 dB, precision voltage and current sources for sensor excitation, and multiple filtering options. It is designed for continuous, automated operation and remote deployment, featuring an ARM Cortex-A9 CPU with 512 MB of RAM and 32 GB of flash memory that provides onboard data storage and processing capabilities along with a Gigabit Ethernet interface for communications (wireless interfaces, such as Wi-Fi and 4G LTE, are also available as build-to-order options). The IMGenie Pro is powered with 5 V_{DC}, housed in a rugged, lightweight composite enclosure that meets MIL-S-901D and MIL-STD-167 requirements, and fully operational from -40 to 85°C .

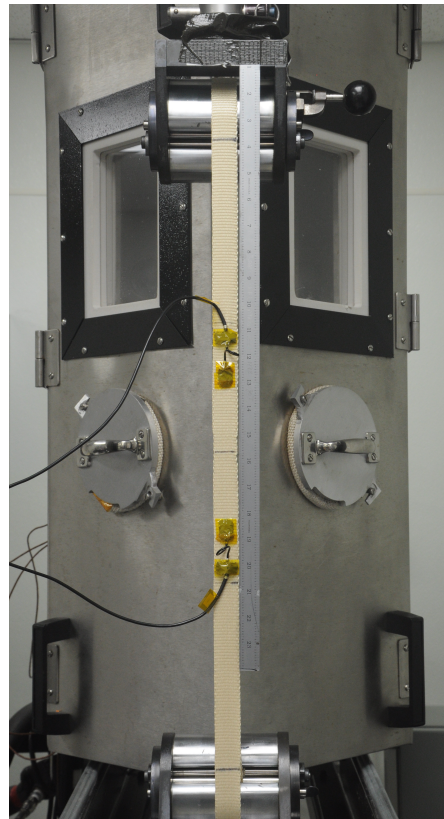
Figure 4. Representative example of a Vectran strip with two sensor packages mounted in the Instron machine.

The testing was conducted on five identical strips of 1-inch Vectran webbing in sequence. Two identical sensor packages, each consisting of a single PZT transducer (¼-inch diameter) and a single thin-foil metal strain gauge (3-mm active gauge length), were bonded to each Vectran strip. The sensor packages were positioned approximately 6 inches apart. Each strip was mounted vertically in the Instron machine, as shown in Figure 4, with a ruler positioned alongside in order to allow measurements of the elongation during the stretching process. The capstan and clamps used to hold the strip are also visible at the top and bottom. The distance between the grips (gauge length) was approximately 10 inches. The sensor packages can also be seen in Figure 4. Note that the sensor packages themselves are on the interior; behind each sensor package is an epoxy blob that serves to provide strain relief for the cabling, which is routed to the data-acquisition hardware. (In the final application, this wiring would be embedded within the Vectran webbing.)

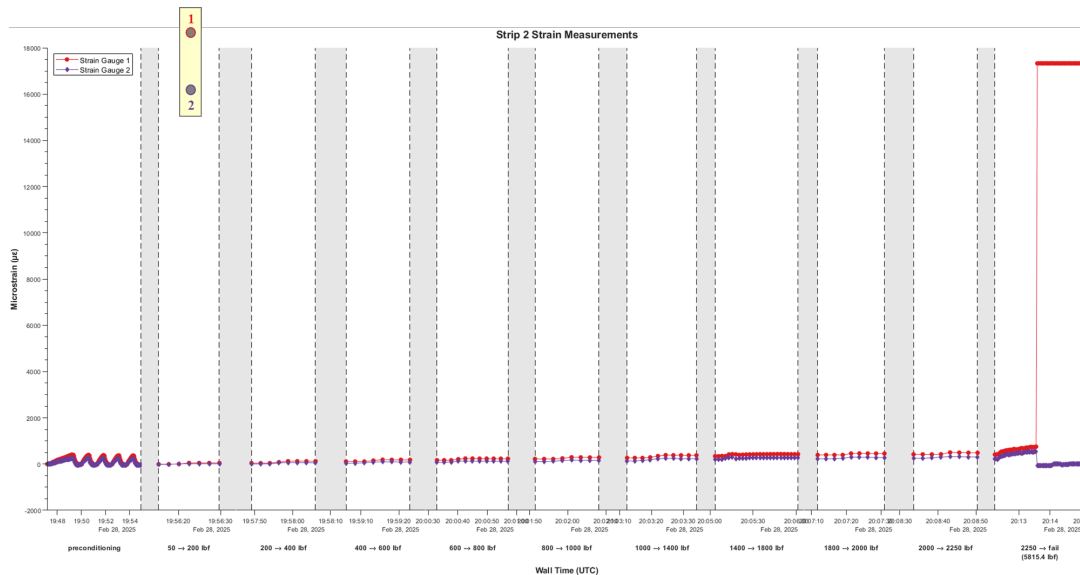
Figure 5A. Representative strain measurements from strip that was stretched to failure.

A representative set of strain measurements for one of the strips that was stretched to failure is shown as Figure 5A. The measurements from strain gauge 1 (on top) are shown in red; the measurements from strain gauge 2 (on bottom) are shown in purple. The horizontal axis is elapsed time, shown continuously. The breaks (gray sections) do not interrupt the horizontal axis (time continues to elapse) but represent the time periods during which strain measurements were disabled in order to perform the

impact tests. Note the oscillating strain pattern during the preconditioning step, and the roughly linear increase in strain during each of the subsequent steps. When the strip failed, the sensor package was damaged, which resulted in invalid, off-scale readings from the strain gauges. Figure 5B plots the same data as Figure 5A, except that the time (horizontal) axis is truncated to remove the invalid, off-scale readings, making it easier to see the trends within the measurements.

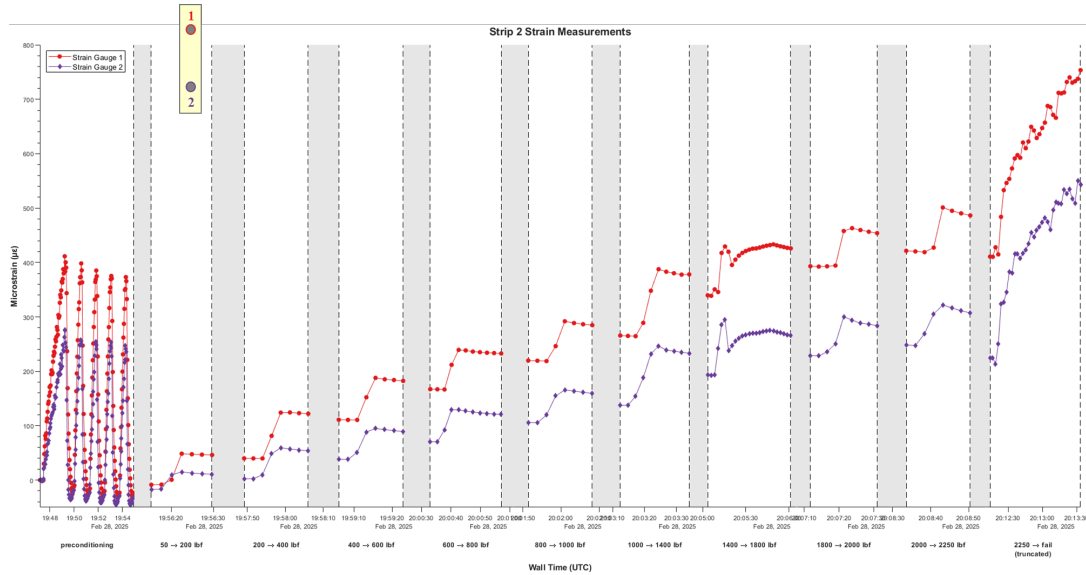
Figure 5B: Truncated view of representative strain measurements from strip that was stretched to failure.

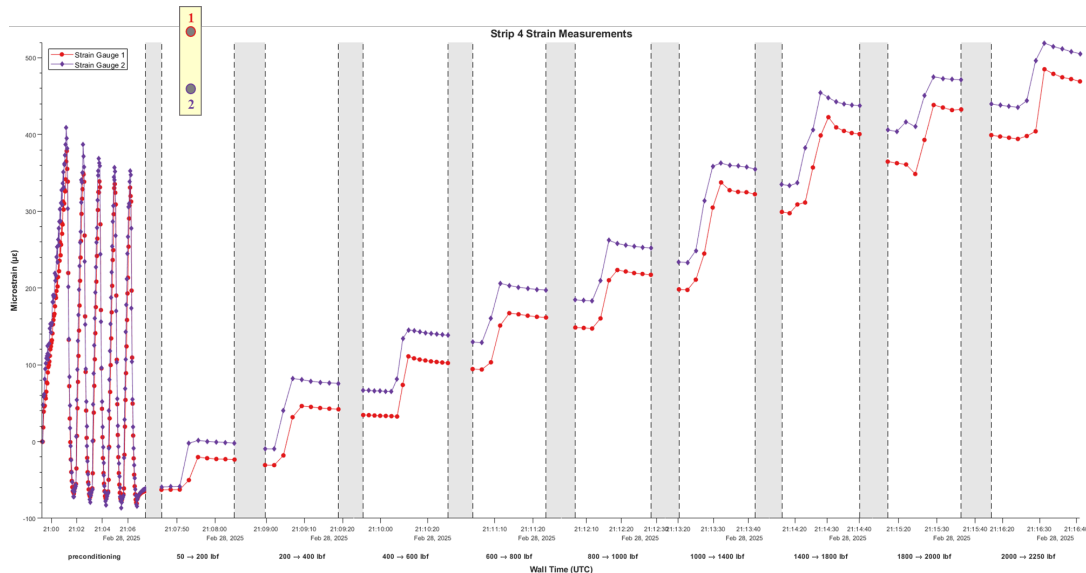
Figure 6. Representative strain measurements from strip that was not stretched to failure.

Figure 6 is a representative plot of strain measurements from a strip that was not stretched to failure (strip 4). Because this strip was not stretched to failure, the full time-series produces a plot that looks just like Figure 5B. Note that two strain gauges show good agreement with one other (although there is some offset, which is to be expected, since this is “raw” data with no calibration or offset factors applied), and the strain measurements are quite repeatable across Figures 5B and 6. This trend of high repeatability was observed across the measurements for all five Vectran strips.

Within each section (the white regions in-between the gray dividers), the strain measurement can be clearly seen to increase, then subsequently begin to decrease gradually. The sustained increase represents the period of active stretching/elongation; the gradual decay represents the “hold” period, during which the Vectran relaxed, resulting in an observed decrease in the strain. In fact, if one interpolates visually across the gray regions, it is clear that the Vectran continues to relax slightly during the impact tests, such that the next set of measurements starts at a slightly lower strain level than the previous set of measurements ended. Note that these sub-durations (periods of sustained elongation, followed by gradual relaxation) are not consistent or repeatable because the timing (starting and stopping of the strain measurement) was done manually and not synchronized to the same clock used to control the Instron machine. Still, it is clear that the strain measurements are reasonable and consistent with what would be expected based on the experimental procedure. This confirms that the sensor package is working well (i.e., that it is sensitive to the strain experienced by the underlying Vectran strip as a result of the increased load/stretching) and that the sensor package survived throughout the entire stretching process, up until the point where the Vectran strip failed.

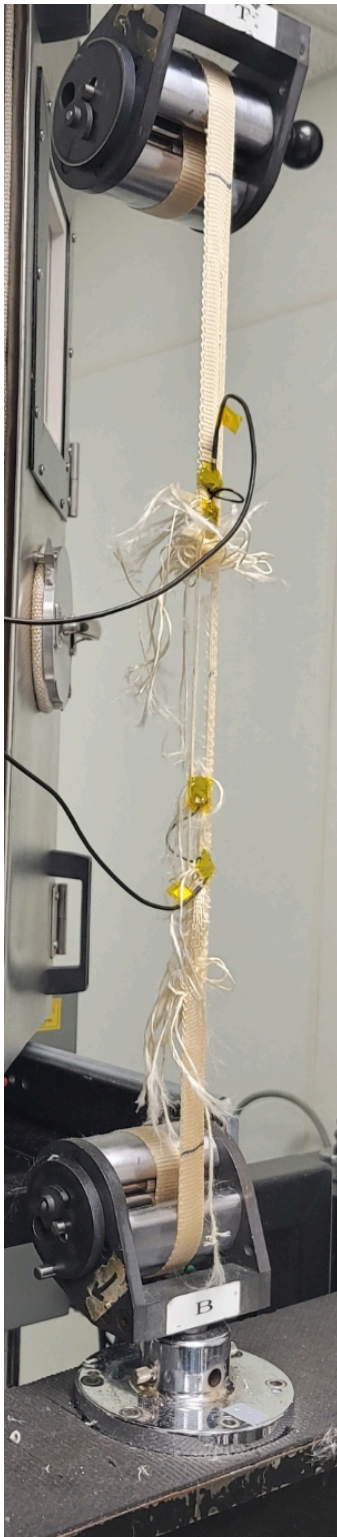
Figure 7A. Broken Vectran strip after pulling to failure.

When the Vectran strip was stretched to the point of failure, it generally ripped at or around the sensor package, causing damage to the sensors themselves, the wiring, or both, as previously noted when explaining the out-of-range measurements at the end of Figure 5A. Figure 7A is a photograph of one of the Vectran strips still loaded in the Instron machine after it was pulled to failure; Figure 7B is a close-up photograph of a failed strap around the sensor package. In both photos, the frayed threads reveal an obvious failure mode. Strip 1 failed at a load of 5823.2 lbf, and strip 2 failed at 5815.4 lbf. By way of comparison, a sixth strip, which was identical except without any sensor package bonded to it, failed at 6300.4 lbf. Therefore, while the sensor package clearly weakens the Vectran webbing at the location where it is installed, reducing its load-bearing capacity from greater than 6000 lbf to less than 6000 lbf, these strips of webbing are only rated up to a tensile strength of 5500 lbf, which is well below even the reduced failure point.

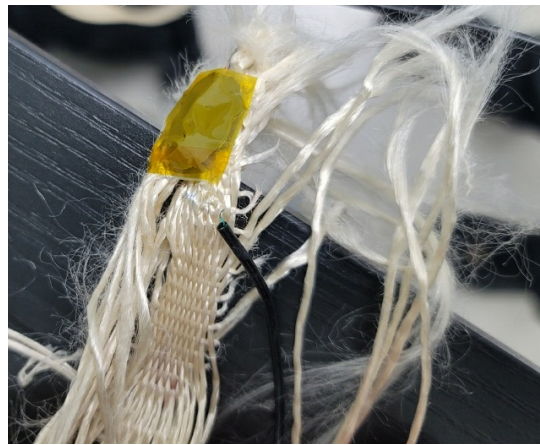
Figure 7B. Close-up of frayed and broken Vectran fibers around sensor package after pulling to failure.

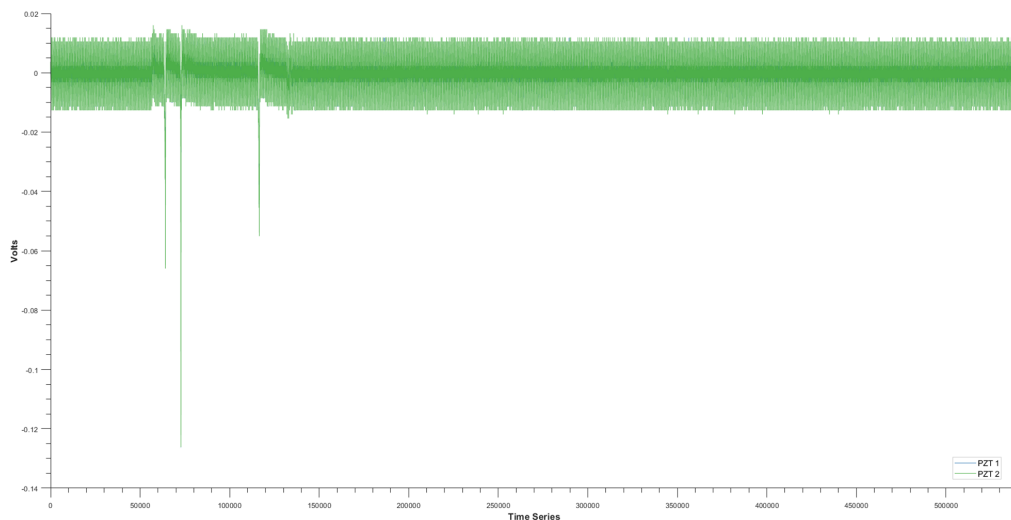
Figure 8. A representative set of dynamic strain measurements from PZT sensors during one particular stretch-and-hold interval.

In addition to the static strain/load measurements that were obtained from the two strain gauges during stretching (Figures 5–6), a series of extremely high-speed measurements were also recorded from the two co-located PZT sensors during stretching, representing high-fidelity dynamic strain measurements. A representative example of these measurements is shown as Figure 8 (in this case, strip #1, when stretched from 1000 to 1400 lbf). The ground noise of approximately ± 0.01 V is plainly visible throughout the entire measurement interval, as are a few small spikes extending below the noise in the region of time where the strip was being stretched continuously by the Instron machine, presumably due to some vibration or non-uniform stretching (resulting in jerkiness) by the machine. Under these particular test conditions, this dynamic strain data is not especially useful, but the tests nevertheless demonstrate that it can be successfully collected.

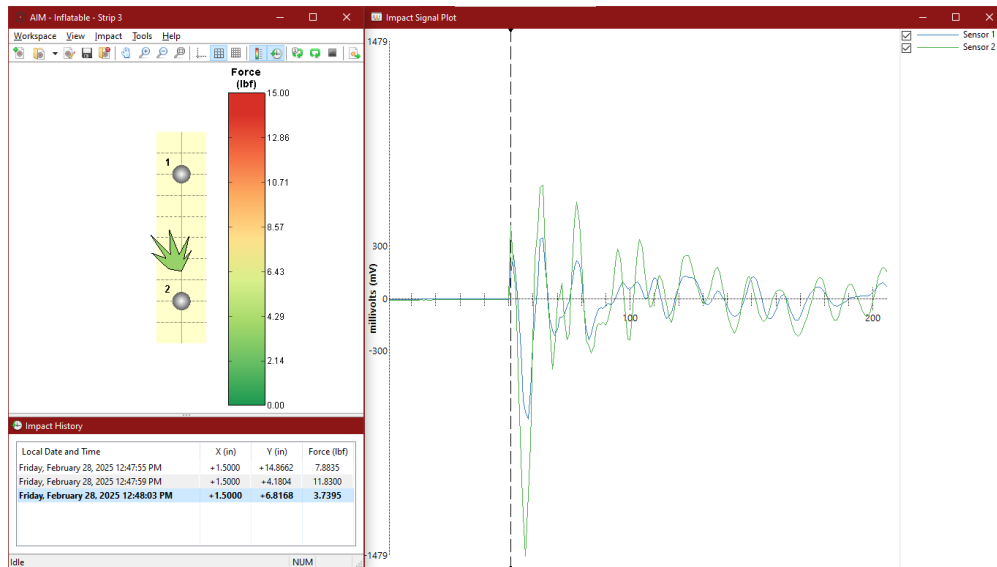
Figure 9. Screenshot of AIM main window and plot window after tapping on strip 3 (A) on top of sensor 1, (B) on top of sensor 2, (C) between sensors 1 and 2.

Finally, in between each stretch-and-hold interval (corresponding to the gray vertical regions in Figures 5–6), the Vectran strip was lightly tapped three times while it was being held under tension in order to test the impact detection capabilities of the SHM system. Each of the three taps were at a different location: the first on top of sensor 1, the second on top of sensor 2, and the third between the two sensors. Even with only two sensors, the system was able to accurately determine the location of the impact (whether it was on top of a sensor or between the two sensors), as well as quantify the force level of the impact. Both the location and force level estimates can be made more accurate by calibration (and, of course, by adding more sensors). Figures 9A–C are screenshots from AIM showing the estimated location of the impact relative to the structure and sensors (starburst pattern), the estimated force of the impact (color of the starburst pattern), and the plot of the signals from both PZT sensors.
