# Real-Time Evaluation of Impact Induced Delamination in UAV Composite Structures Using Fiber Optic Sensors

BYEONG-WOOK JANG

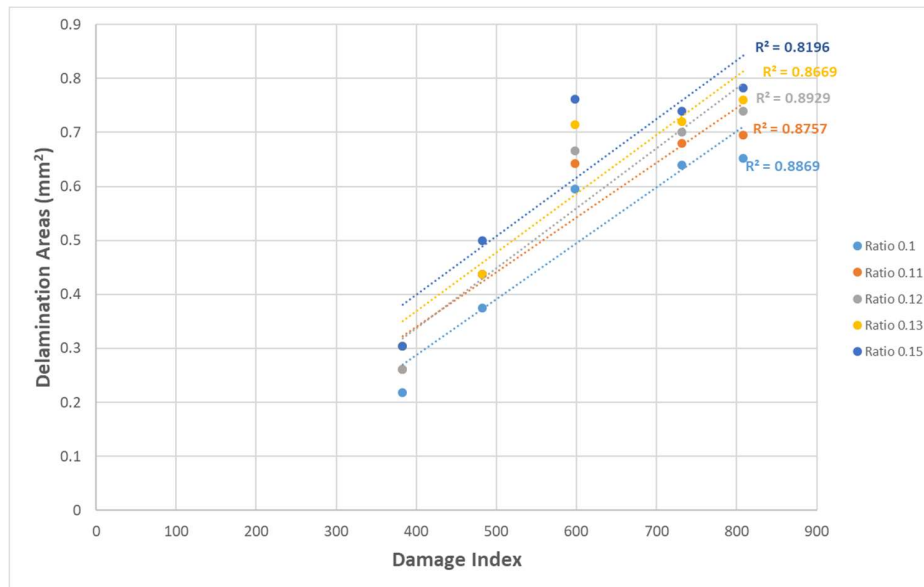
Figure 4. Damage indices versus delamination areas in different ratios.

To decide the threshold value for counting the path numbers which have the short lengths related to the damages, numerous values were assessed as a ratio to the average of the total peak lengths in each signal. In order to find the appropriate ratio value, various plots were obtained between the damage index and delamination areas as shown in Figure 4. The damage index is calculated by dividing the number of short path lengths by the number of total path lengths.

Figure 4 also shows each  $R^2$  value as a result of linear regressions in all cases. The closer the  $R^2$  value is to 1, the more accurate the damage area can be assessed. In this study, 0.8629 is the highest  $R^2$  value. Although this value may be considered relatively low compared to other studies, it is sufficient to judge the tendency of the damaged area changes according to different impact energies. Since the magnitude of delamination area is a major factor in determining the structural health in an operating situation, this

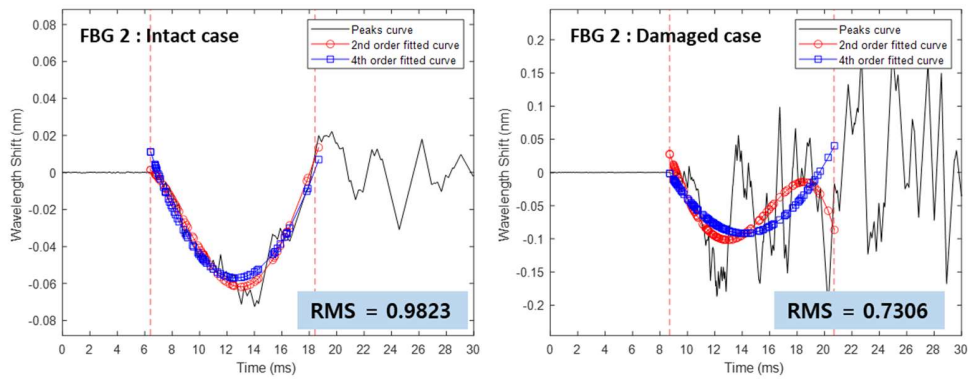
Figure 6. Impact signals and fitted curves of FBG sensor 2.

Figure 6 shows the impact signals of FBG sensor 2 in the intact and damaged cases, respectively. In these signals, the same characteristics as the impact signals in the previous experiments could be found. In order to validate the usefulness of the proposed damage detection method, the RMS values were calculated between the 2<sup>nd</sup> and 4<sup>th</sup> order fitted curves in both cases. Then, it can be found that the RMS value decreased to a number much lower than 1 when damage occurred. It was confirmed that the same result was obtained with all other sensor signals. From these results, the proposed damage detection method was successively validated about the full scale structure.
