Ultrasonic Guided Wave Based Damage Detection of Engine Composite Fan Blades

ABSTRACT

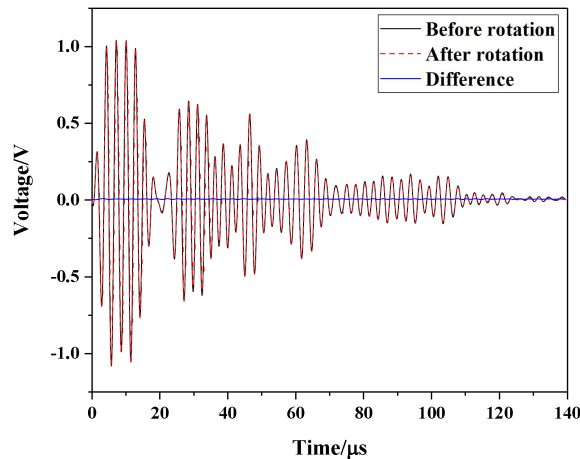
Figure 3. Baseline signal before and after rotation.

Before damage can be detected, the baseline signal is acquired on undamaged blades, which is used to compare the signals when damage occurs. The 4 sensors take turns to individually excite the signals and the other sensors receive the signals, and a total of 12 signals are acquired. To test the repeatability of the baseline signal, the blade speed was increased to 1000 rpm and the rotation was stopped for signal acquisition after the rotation lasted for 10 minutes. The baseline signal excited at sensor 1 and received at sensor 2 is shown in Figure 3. The signal envelope is unchanged after the rotation, and the difference between the signals approximates a smooth line with good signal repeatability. The sensor detection signal embedded in the blade was stable and the use of conductive slip rings has not affected the baseline signal. Therefore, this experimental protocol can be used to simulate the damage detection of engine blades and it is feasible to use this acquisition signal as a baseline signal.

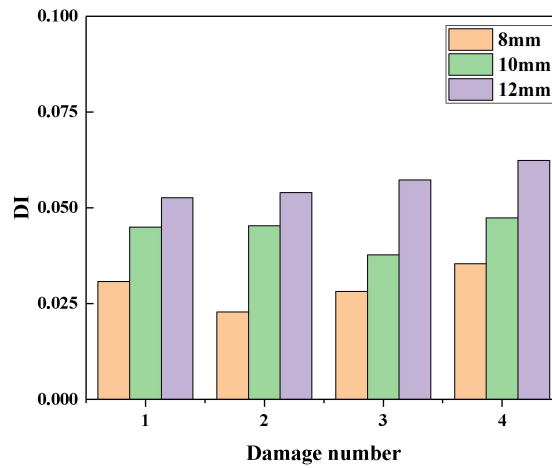
Figure 5. The DI_s for different locations and sizes of damage.

The edge length of the vacuum sealant was changed to 10mm and 12mm, and the damage was quantified after it was pasted again on the original prefabricated damage location. The DI_s calculated by Eq. 4 for different damage locations with different damage sizes is shown in Figure 5. The values of DI_s and the fitted parameters are shown in Table II. The quantitative results show that the DI_s rises gradually as the damage size increases, with a similar gradient of change in the DI_s value at each location. The change in the scale factor for a linear fit to the relationship between DI_s and damage size using Eq. 5 floated within 0.0027, which demonstrated a similar linear relationship between damage size and DI_s at multiple locations. Therefore, the structure of variable curvature and thickness has less influence on the results of damage quantification when damage is detected on a small area of composite blades. The damage quantification results consistently demonstrate that the method is effective for quantifying blade damage for variable curvature and thickness.

Damage location number	DI_s at 8mm	DI_s at 10mm	DI_s at 12mm	β	b
1	0.0308	0.045	0.0526	0.0056	2.38
2	0.0228	0.0453	0.0540	0.0083	5.10
3	0.0282	0.0377	0.0573	0.0075	4.57
4	0.0354	0.0474	0.0624	0.0068	2.86
